Re: Pocono Mountains Municipal Airport (MPO) Annual Safety Inspection

On October 25, 2018, an airport safety inspection and Airport Master Record (5010) update were conducted at the Schuylkill County Airport. This letter outlines the findings by our regional Aviation Safety Specialist, Mr. John Logan, and includes a copy of the updated Airport Master Record (Form 5010-1) for your review.

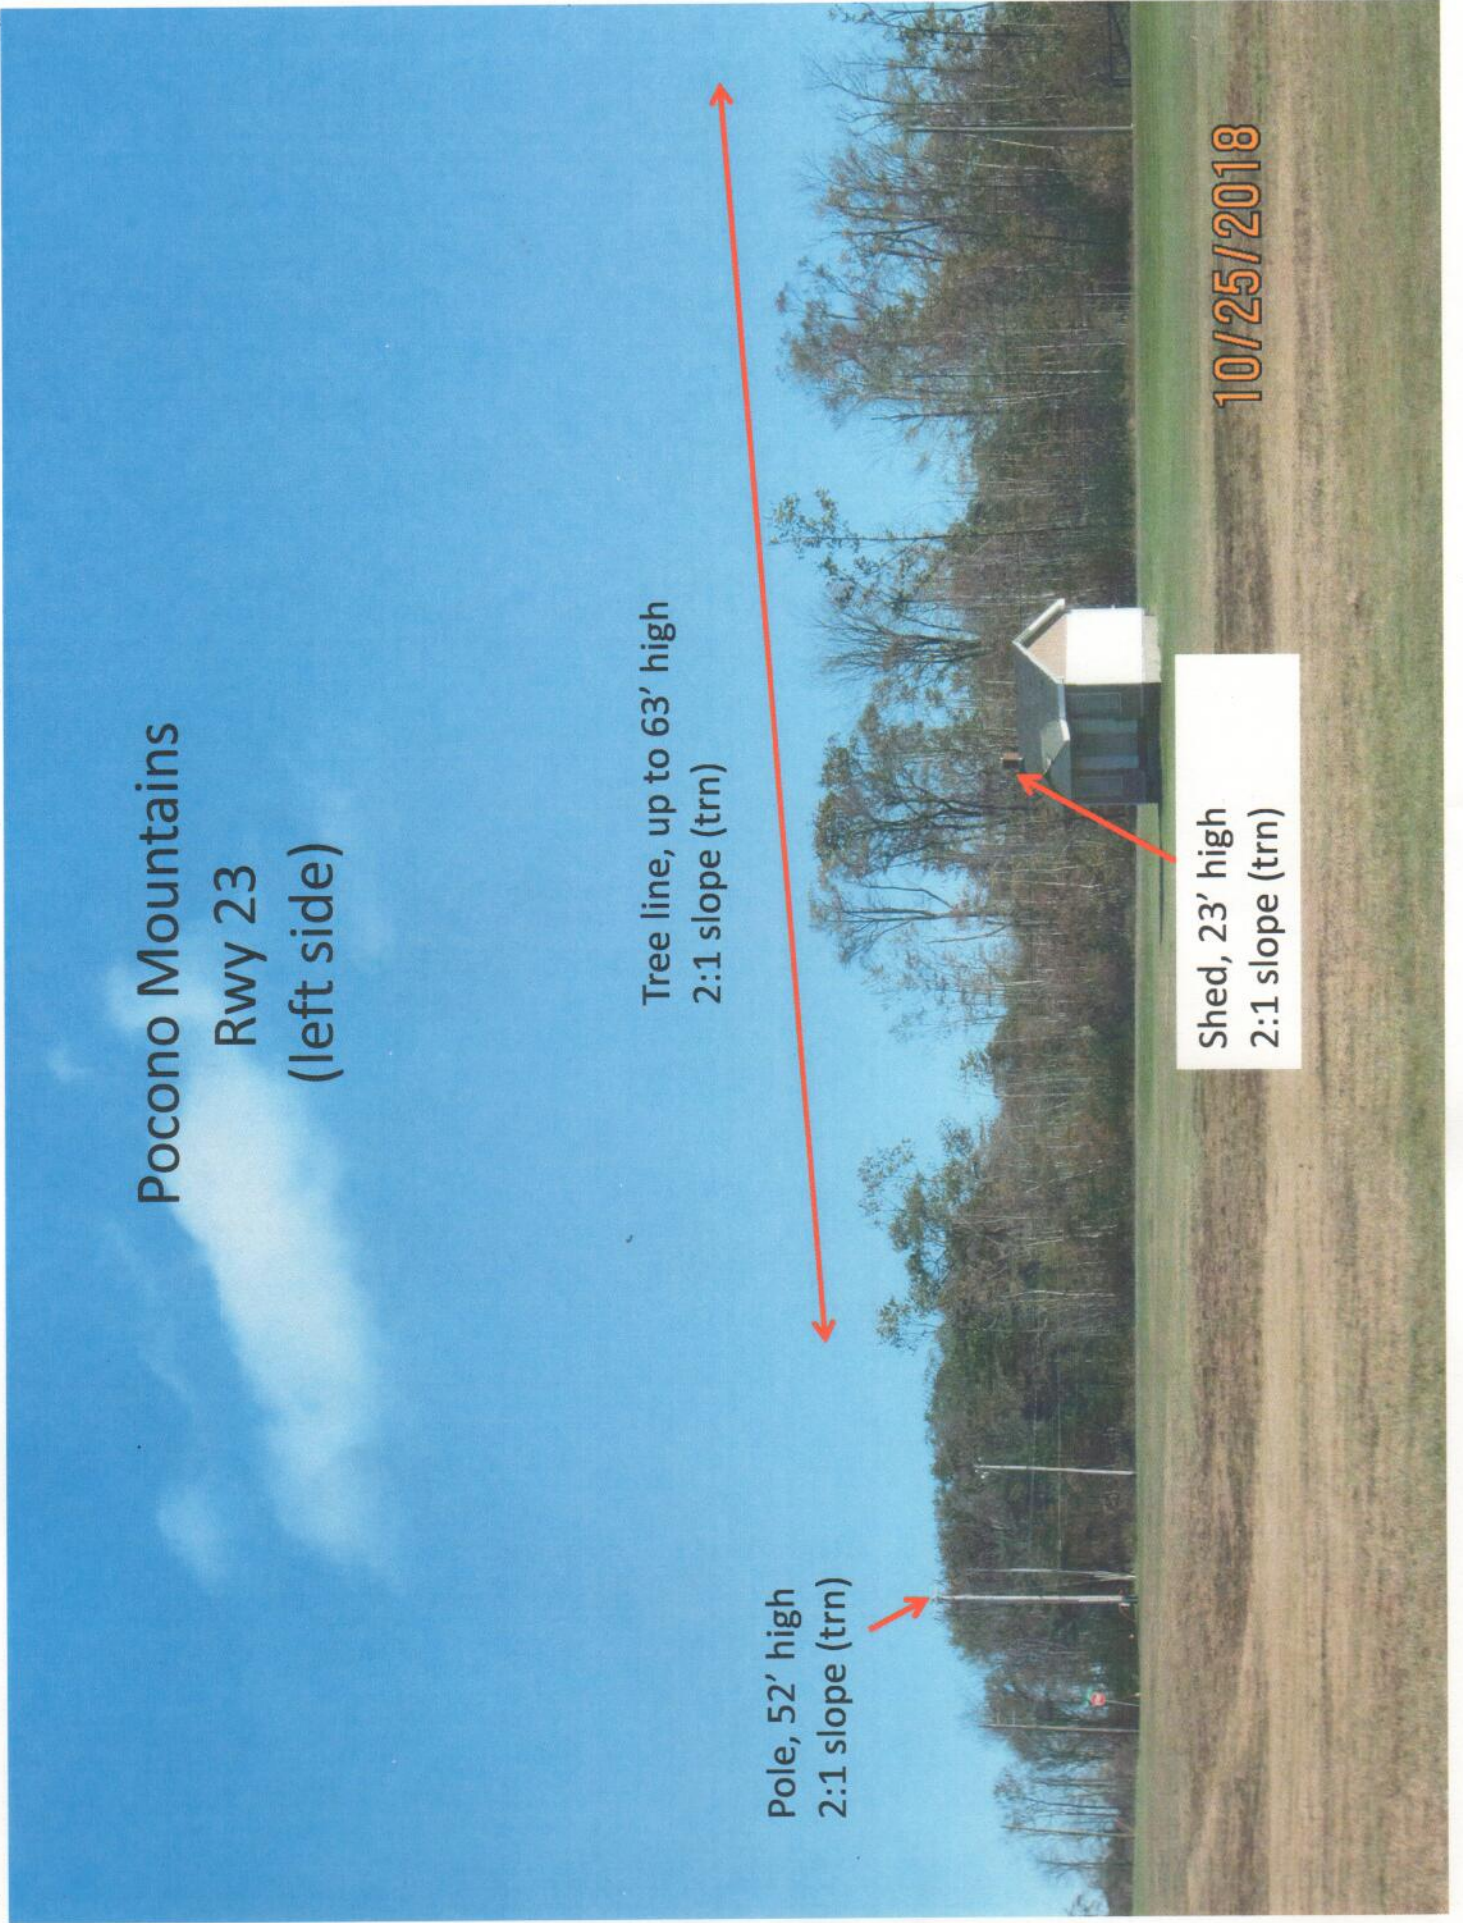
Pocono Mountains
Rwy 23
(left side)

Pole, 52' high
2:1 slope (trn)

Tree line, up to 63' high
2:1 slope (trn)

Shed, 23' high
2:1 slope (trn)

- a. Trees 763' out, 763' right, 105' high (6:1 slope)
- b. Pole 650' out, 472' right, 56' high (5:1 slope)
- c. Trees 1,434' out, 438' left, 82' high (3:1 slope)
- d. Pole 529' out, 384' left, 52' high (2:1 slope)
- e. Shed 258' out, 307' left, 23' high (2:1 slope)
- f. Tree line 299' out, 412' left, 63' high (2:1 slope)

NOTE: The above transitional surface obstructions are considered **hazards to the runway's navigable airspace** and should be mitigated at the earliest opportunity. If you are unable to remove or lower the transitional trees recommend completing an FAA Form 7460-1, for a formal assessment by the FAA on their acceptability. The completed form should be forwarded to the Bureau for review and subsequent forwarding to the FAA. Feel free to contact your regional specialist if you need assistance.

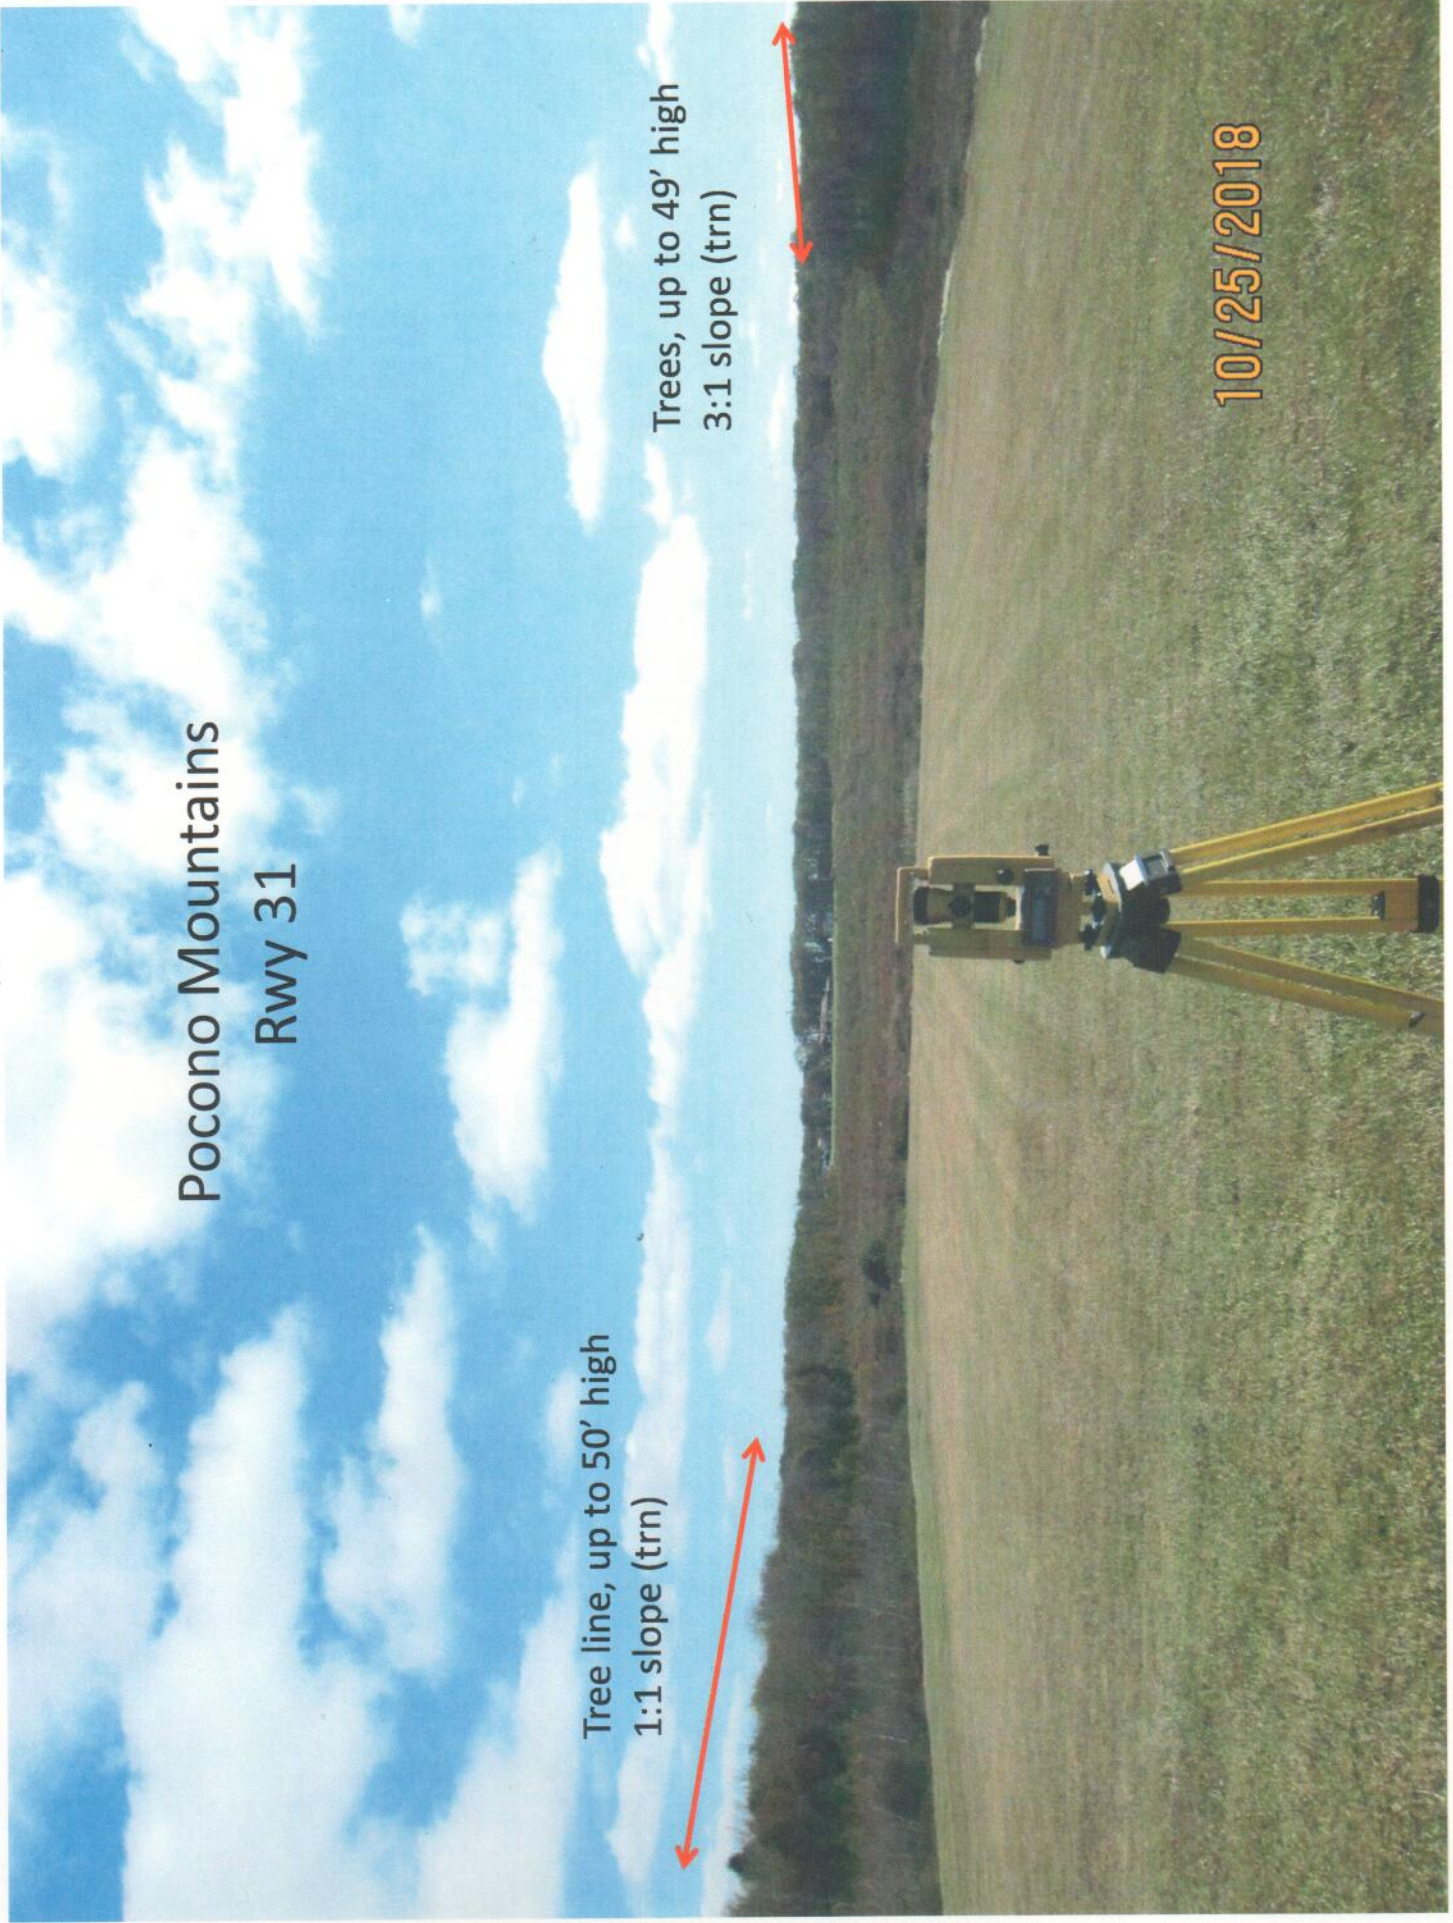
Pocono Mountains
Rwy 31

Tree line, up to 50' high
1:1 slope (trn)

Trees, up to 49' high
3:1 slope (trn)

- a. Tree line 89' back, 462' right, 51' high (4:1 slope)
- b. Tree line 826' out, 385' right, 50' high (1:1 slope)
- c. Trees 1068' out, 453' left, 49' high (3:1 slope)
- d. Tree line 79' out, 342' left, 42' high (2:1 slope)
- e. Tree line 375' back, 432' left, 56' high (3:1 slope)

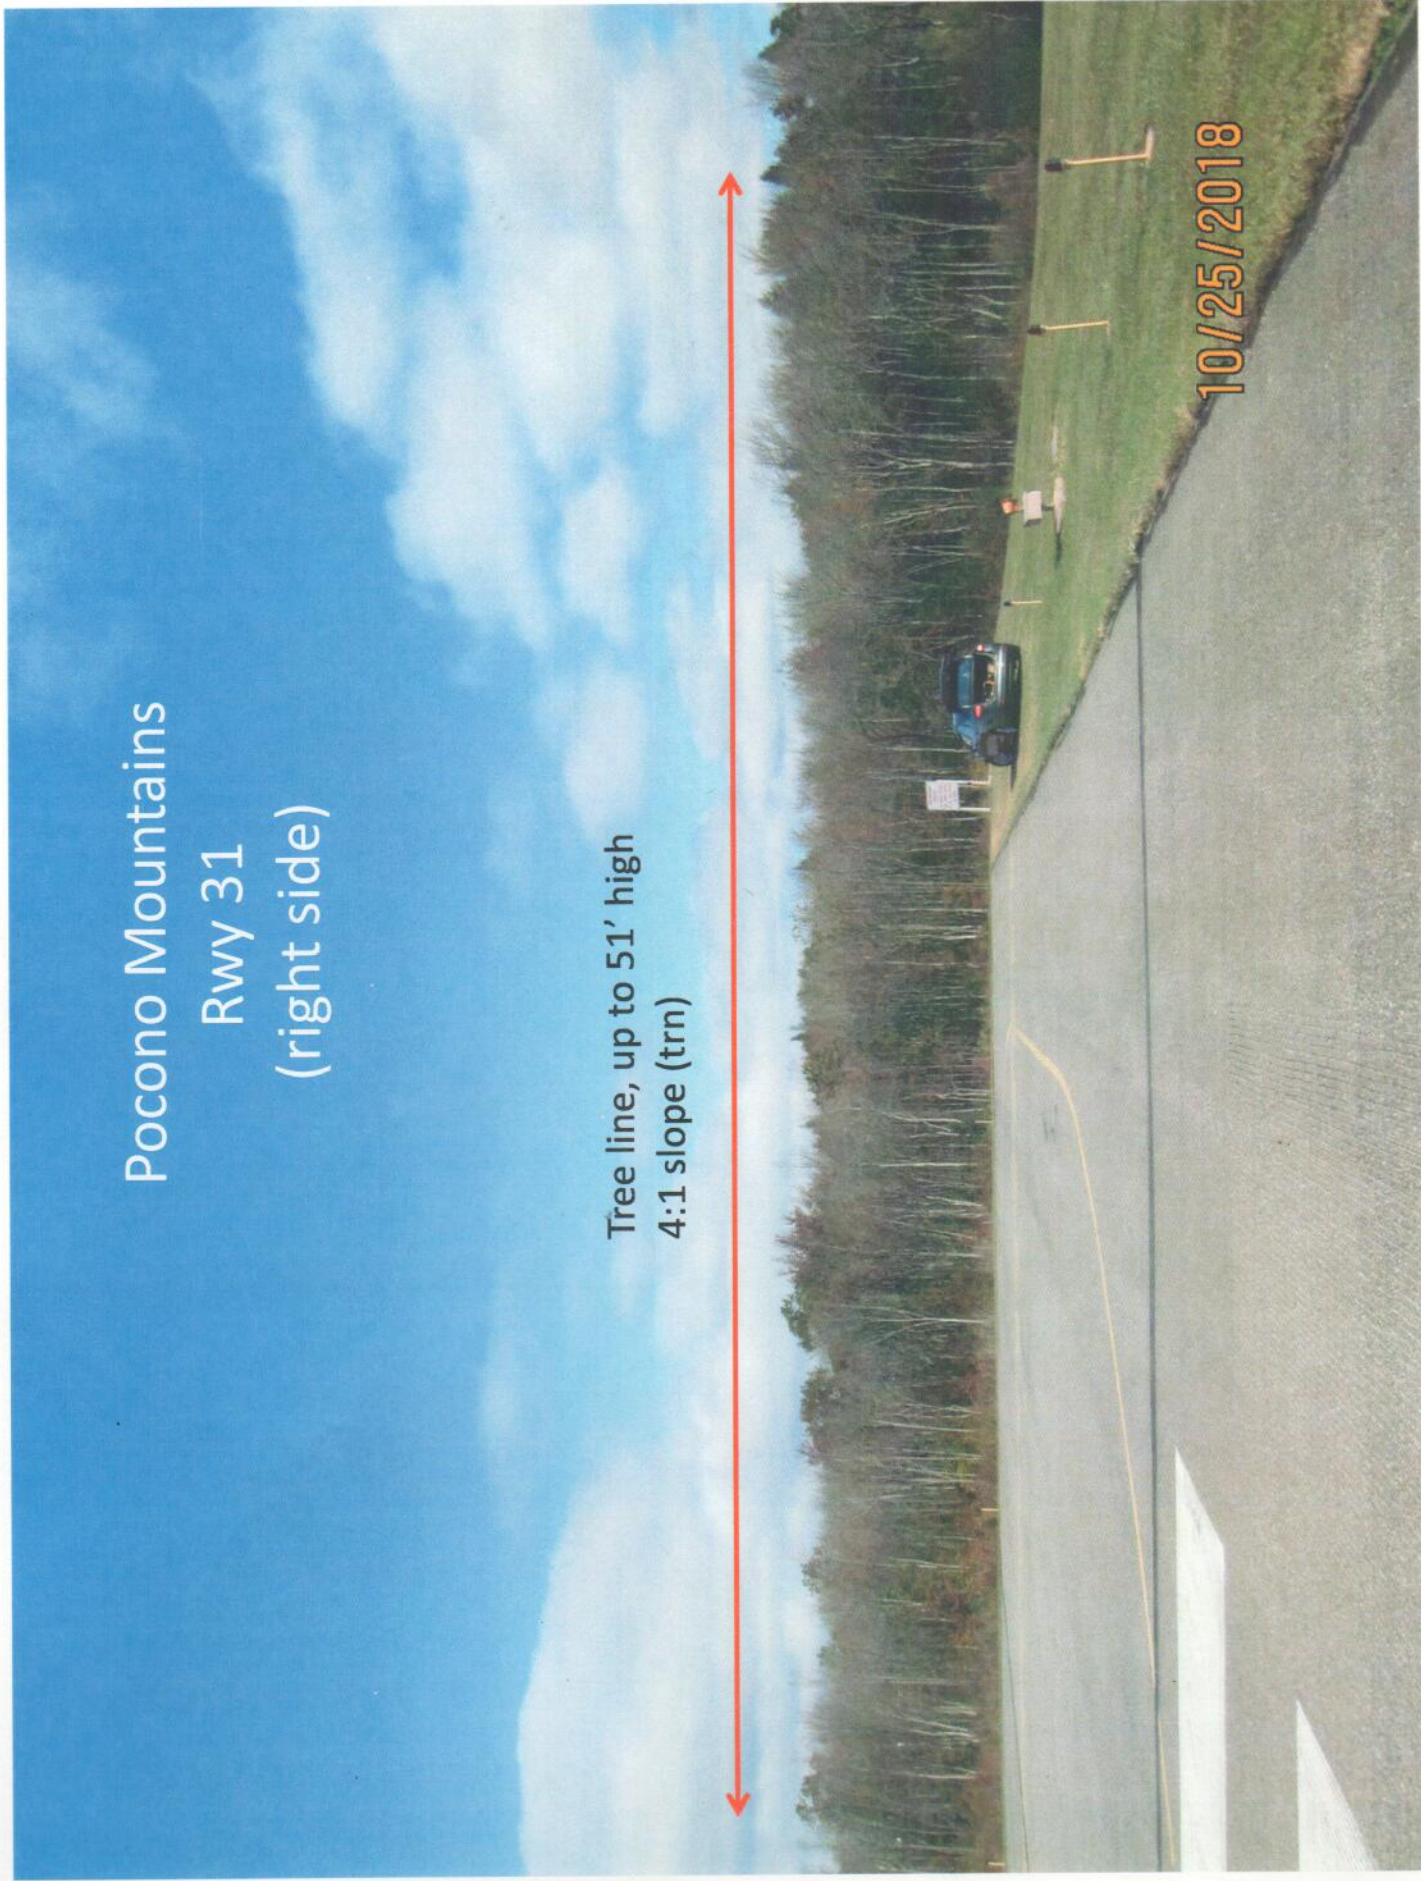
Pocono Mountains
Rwy 31
(right side)

Tree line, up to 51' high
4:1 slope (trn)

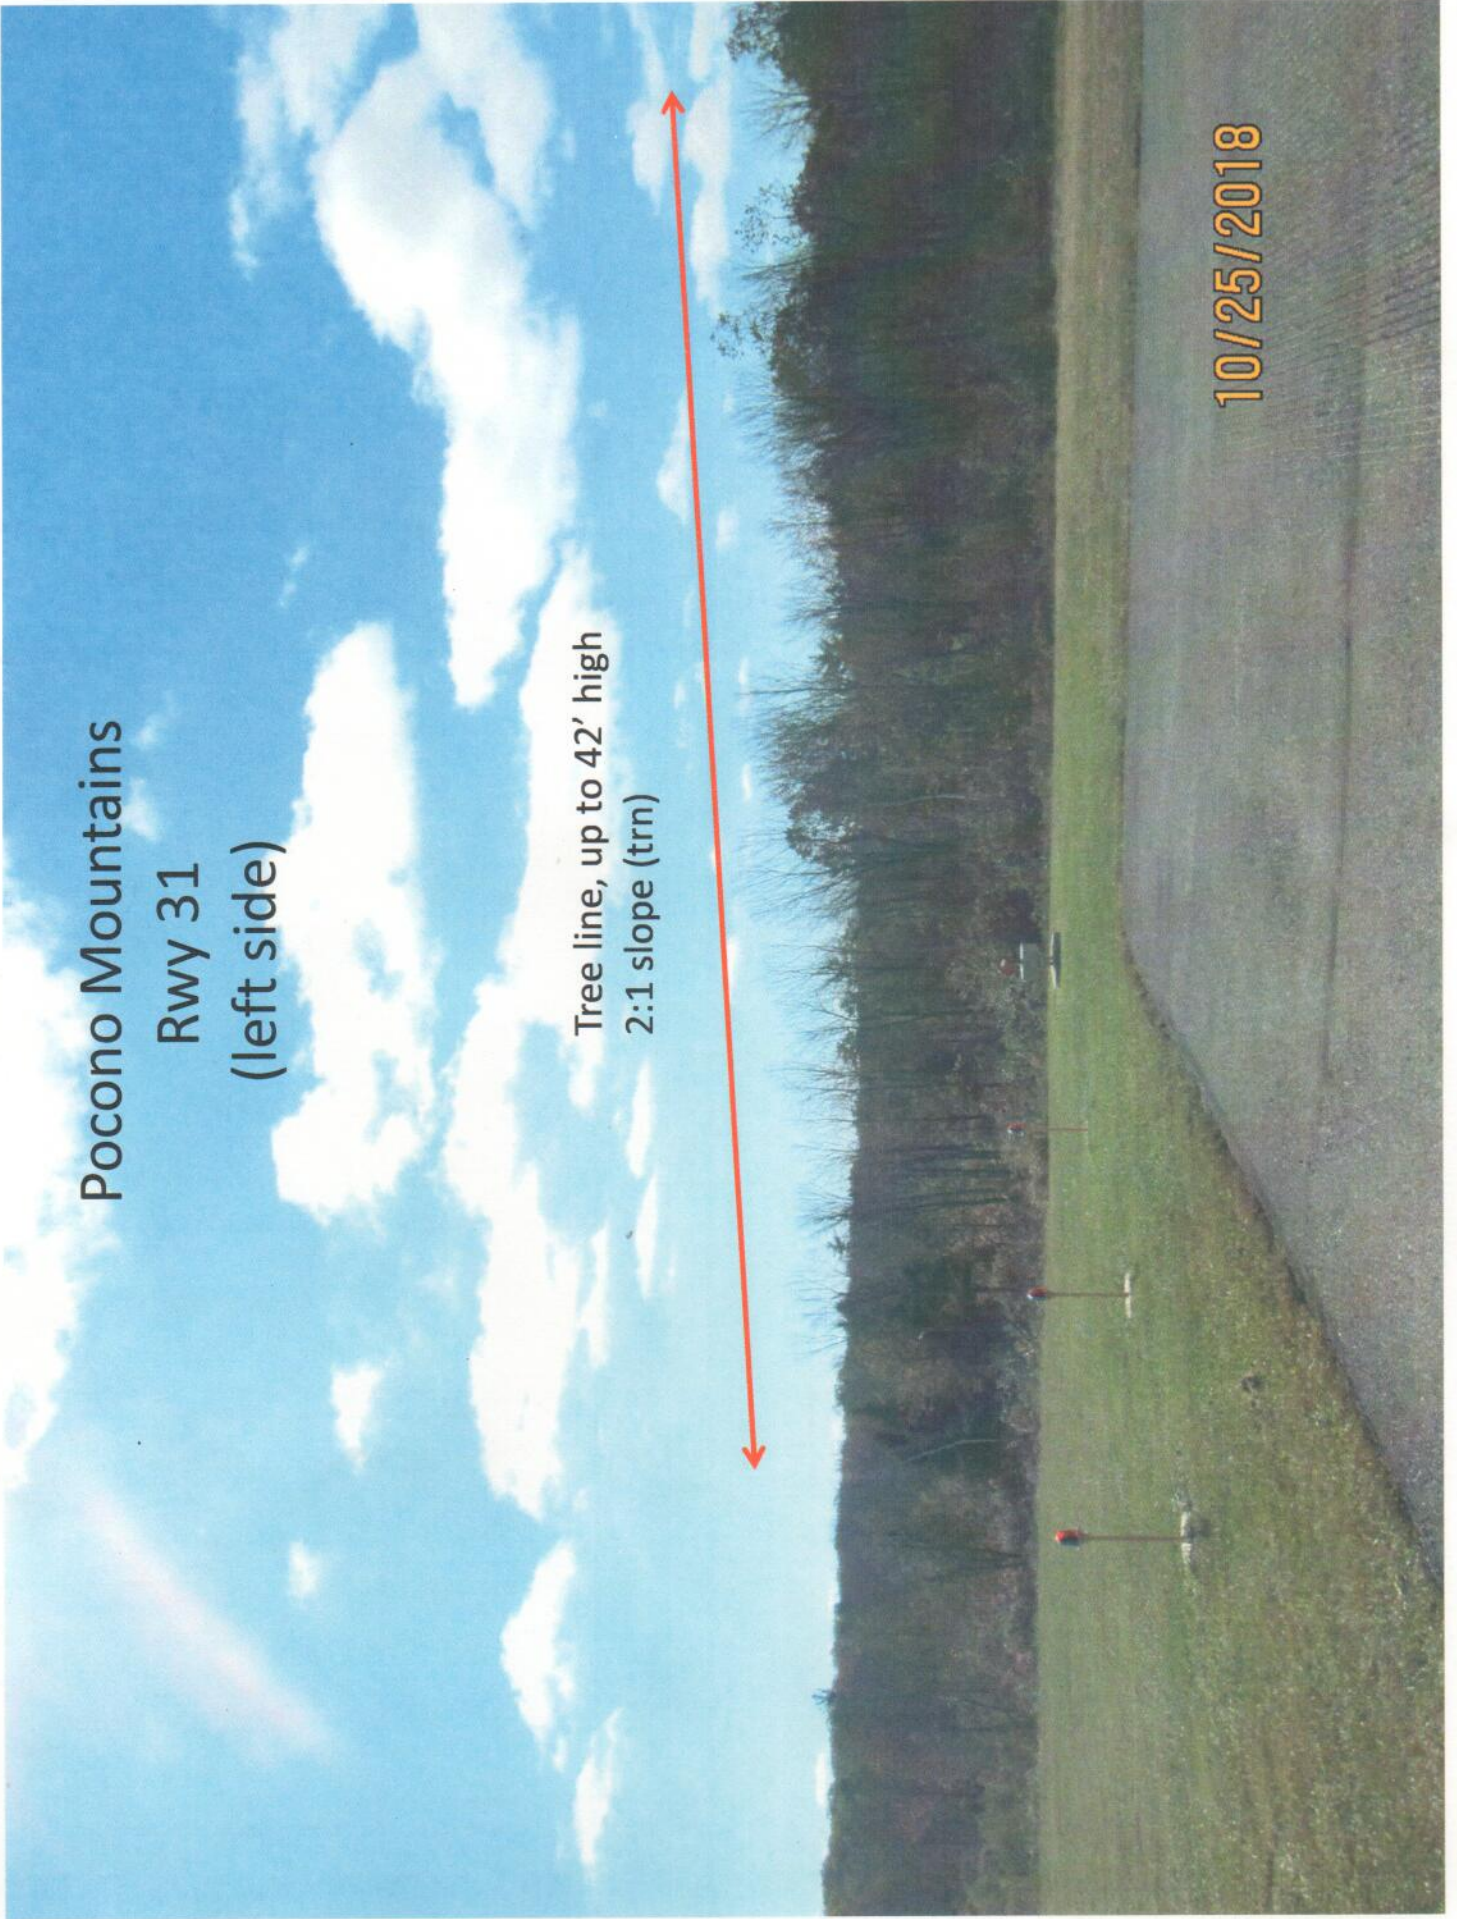
Pocono Mountains
Rwy 31
(left side)

Tree line, up to 42' high
2:1 slope (trn)

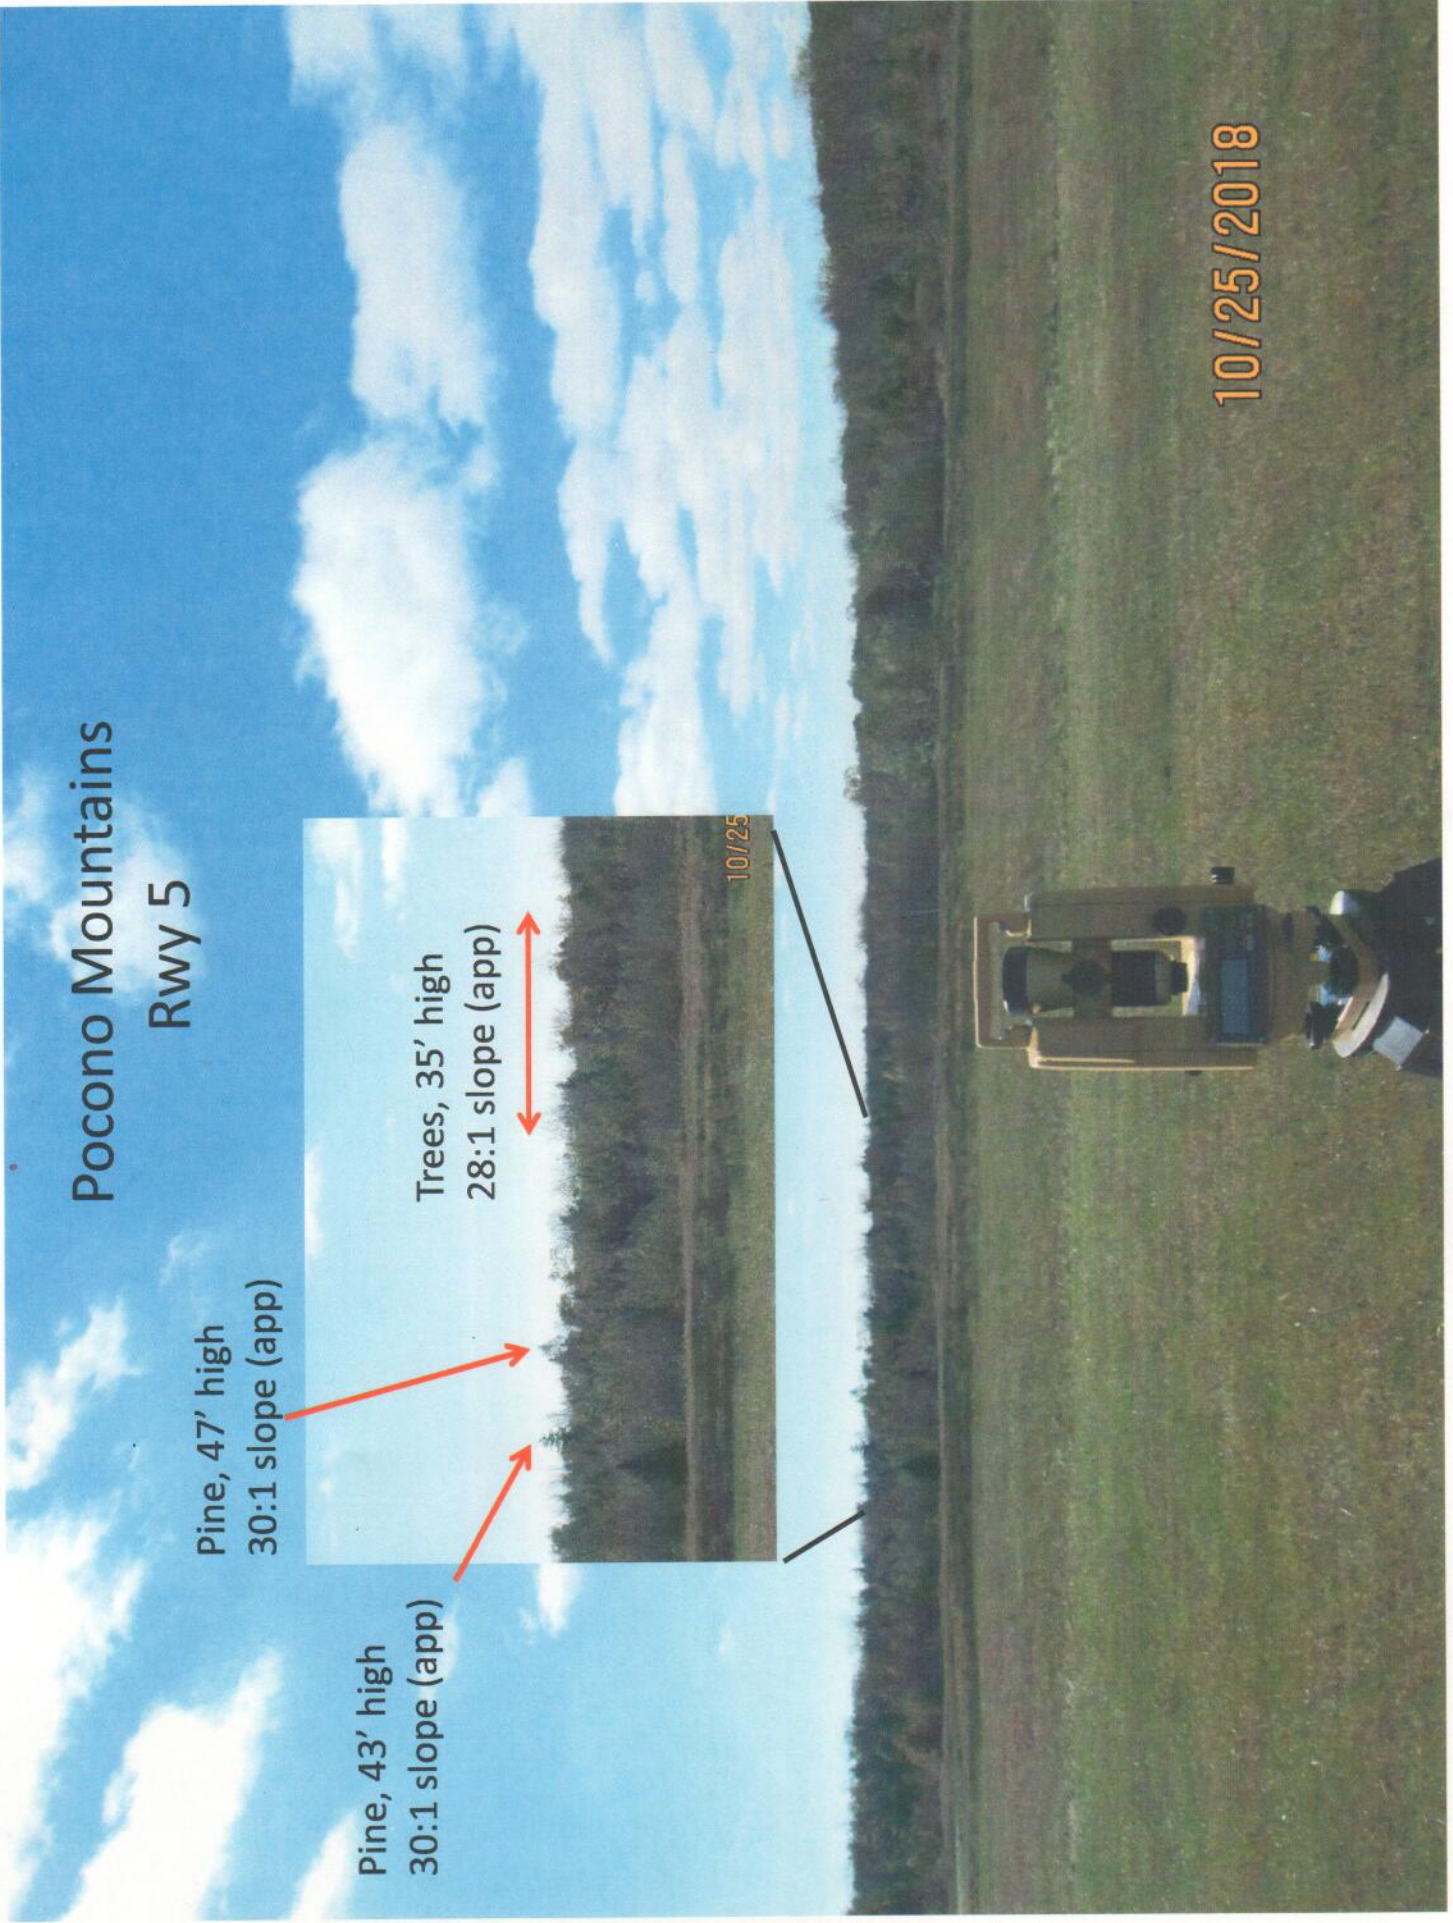
Pocono Mountains

Pine, 47' high
30:1 slope (app)

Pine, 43' high
30:1 slope (app)

Trees, 35' high
28:1 slope (app)

- Runway 05: (Other than utility runway – NPI approach, 34:1 slope)
 - a. Pine 1,486' out, 398' right, 43' high (30:1 slope)
 - b. Pine 1,628' out, 375' right, 47' high (30:1 slope)

- c. Tree 1,180' out, 103' right, 35' high (28:1 slope)
 - d. Trees 964' out, 118' left, 30' high (25:1 slope)
 - e. Tree 958' out, 292' left, 40' high (18:1 slope)

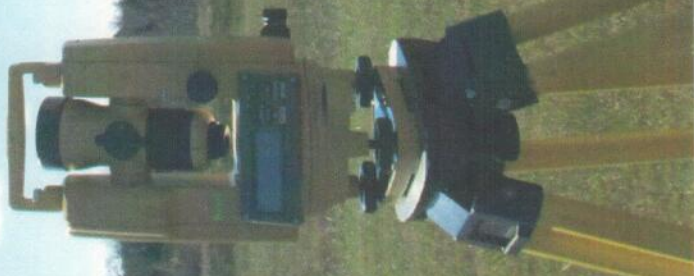
Pocono Mountains
Rwy 5
(left side)

Trees, 30' high
25:1 slope (app)

Tree, 40' high
18:1 slope (app)

Tree line, up to 50' high
2:1 slope (trn)

- a. Tree line, 103' out, 651' right, 74' high (5:1 slope)
- b. Tree 953' out, 424' left, 50' high (2:1 slope)

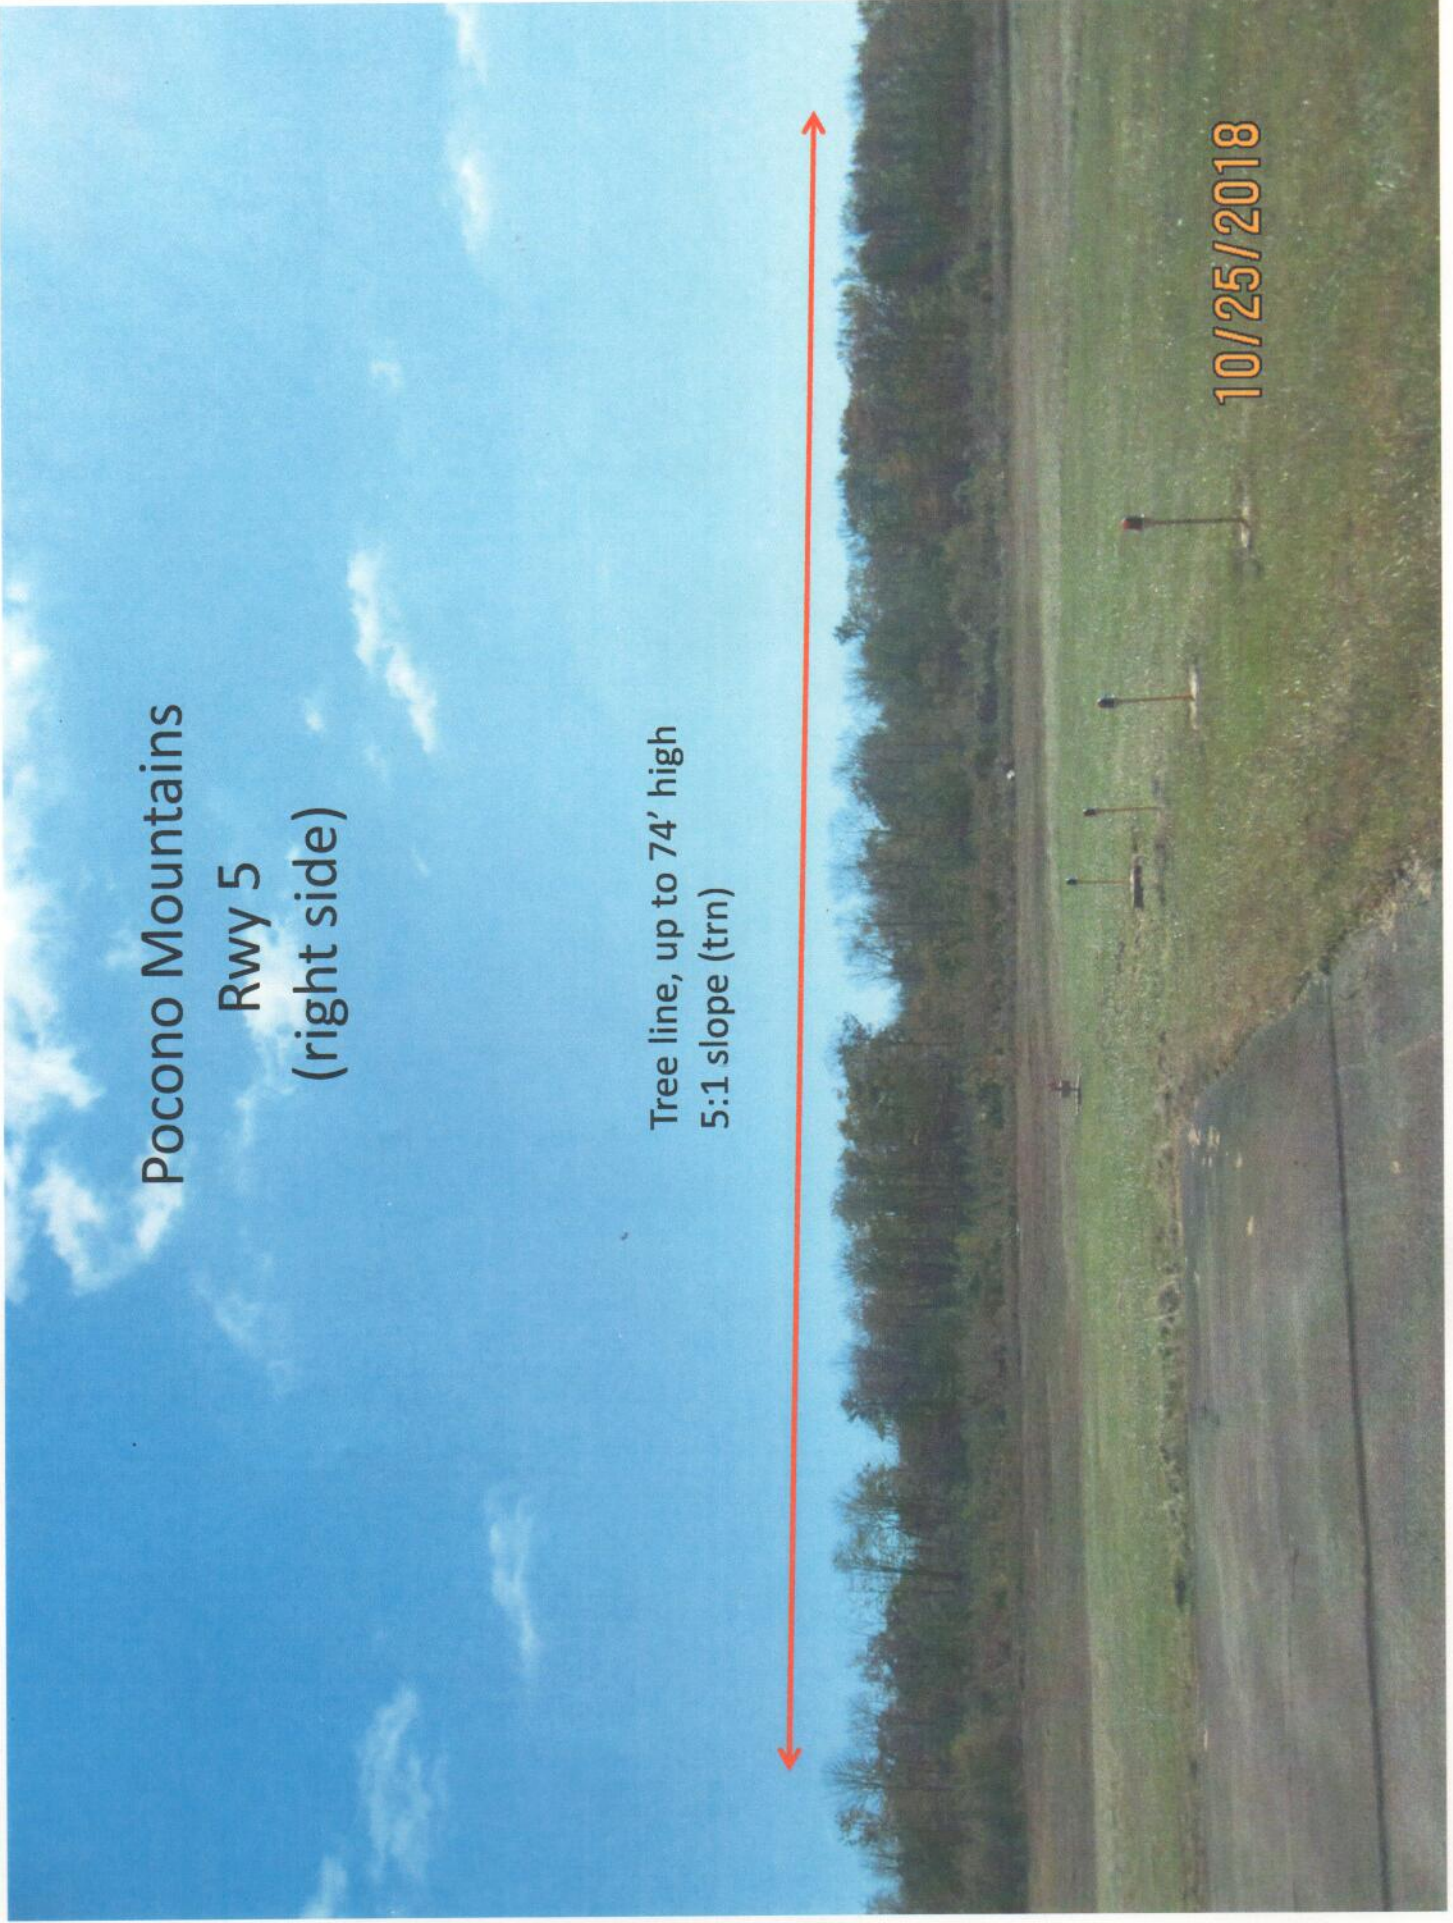
Pocono Mountains
Rwy 5
(right side)

Tree line, up to 74' high
5:1 slope (trn)

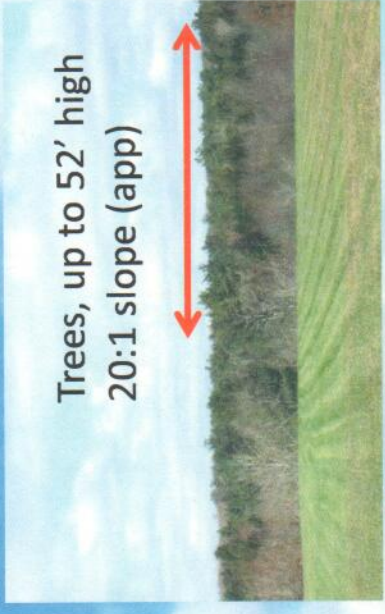
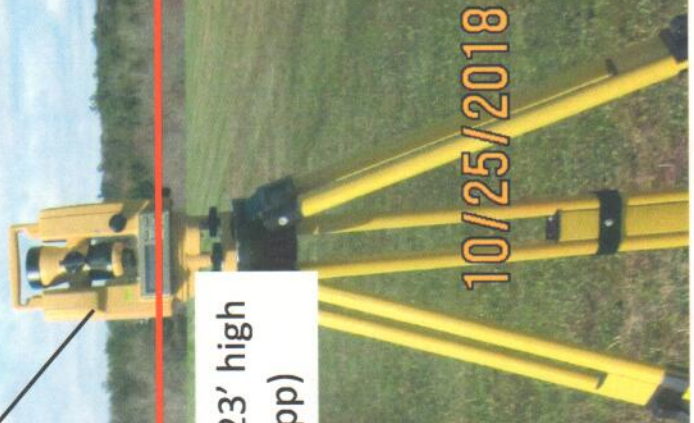
Pocono Mountains Rwy 13

Trees, up to 46' high
2:1 slope (trn)

Trees, up to 40' high
9:1 slope (app)

Pine, 37' high
14:1 slope (app)

Close Trees, 23' high
20:1 slope (app)

Trees, up to 52' high
20:1 slope (app)

NOTE: The current displaced threshold on Runway 13 (at 501 feet) accommodates for the above listed obstructions. No action necessary.

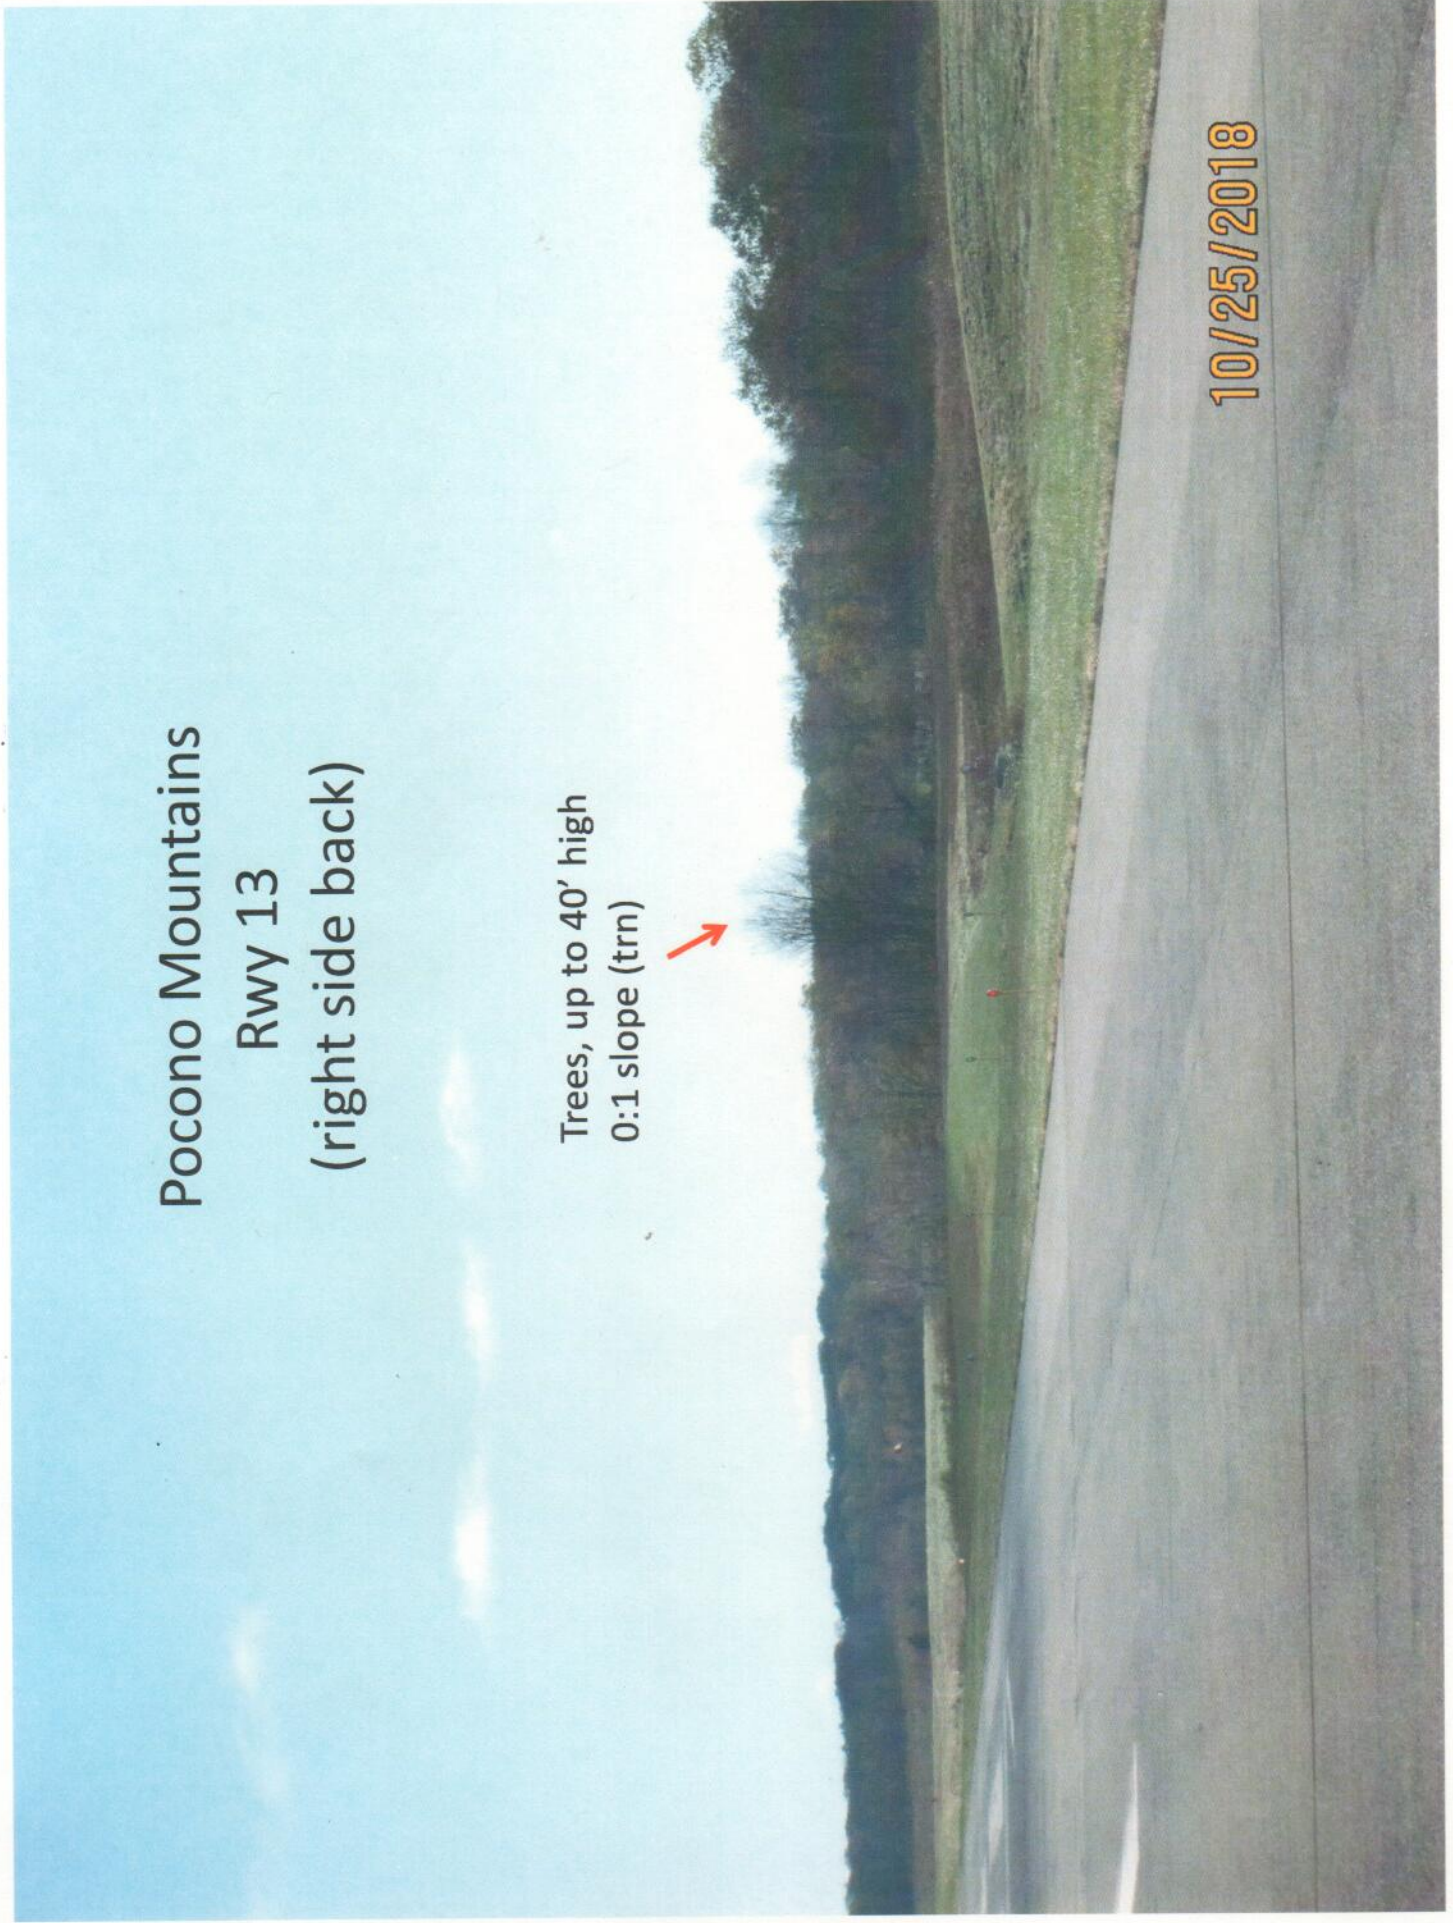
Pocono Mountains
Rwy 13
(right side back)

Trees, up to 40' high
0:1 slope (trn)

- a. Trees, 1,671' back, 264' right, 40' high (0:1 slope)
- b. Tree line 43' back, 411' right, 45' high (3:1 slope)
- c. Trees 416' out, 375' right, 46' high (2:1 slope)
