Re: Pocono Mountains Municipal Airport (MPO) Annual Safety Inspection

On October 25, 2018, an airport safety inspection and Airport Master Record (5010) update were conducted at the Schuylkill County Airport. This letter outlines the findings by our regional Aviation Safety Specialist, Mr. John Logan, and includes a copy of the updated Airport Master Record (Form 5010-1) for your review.

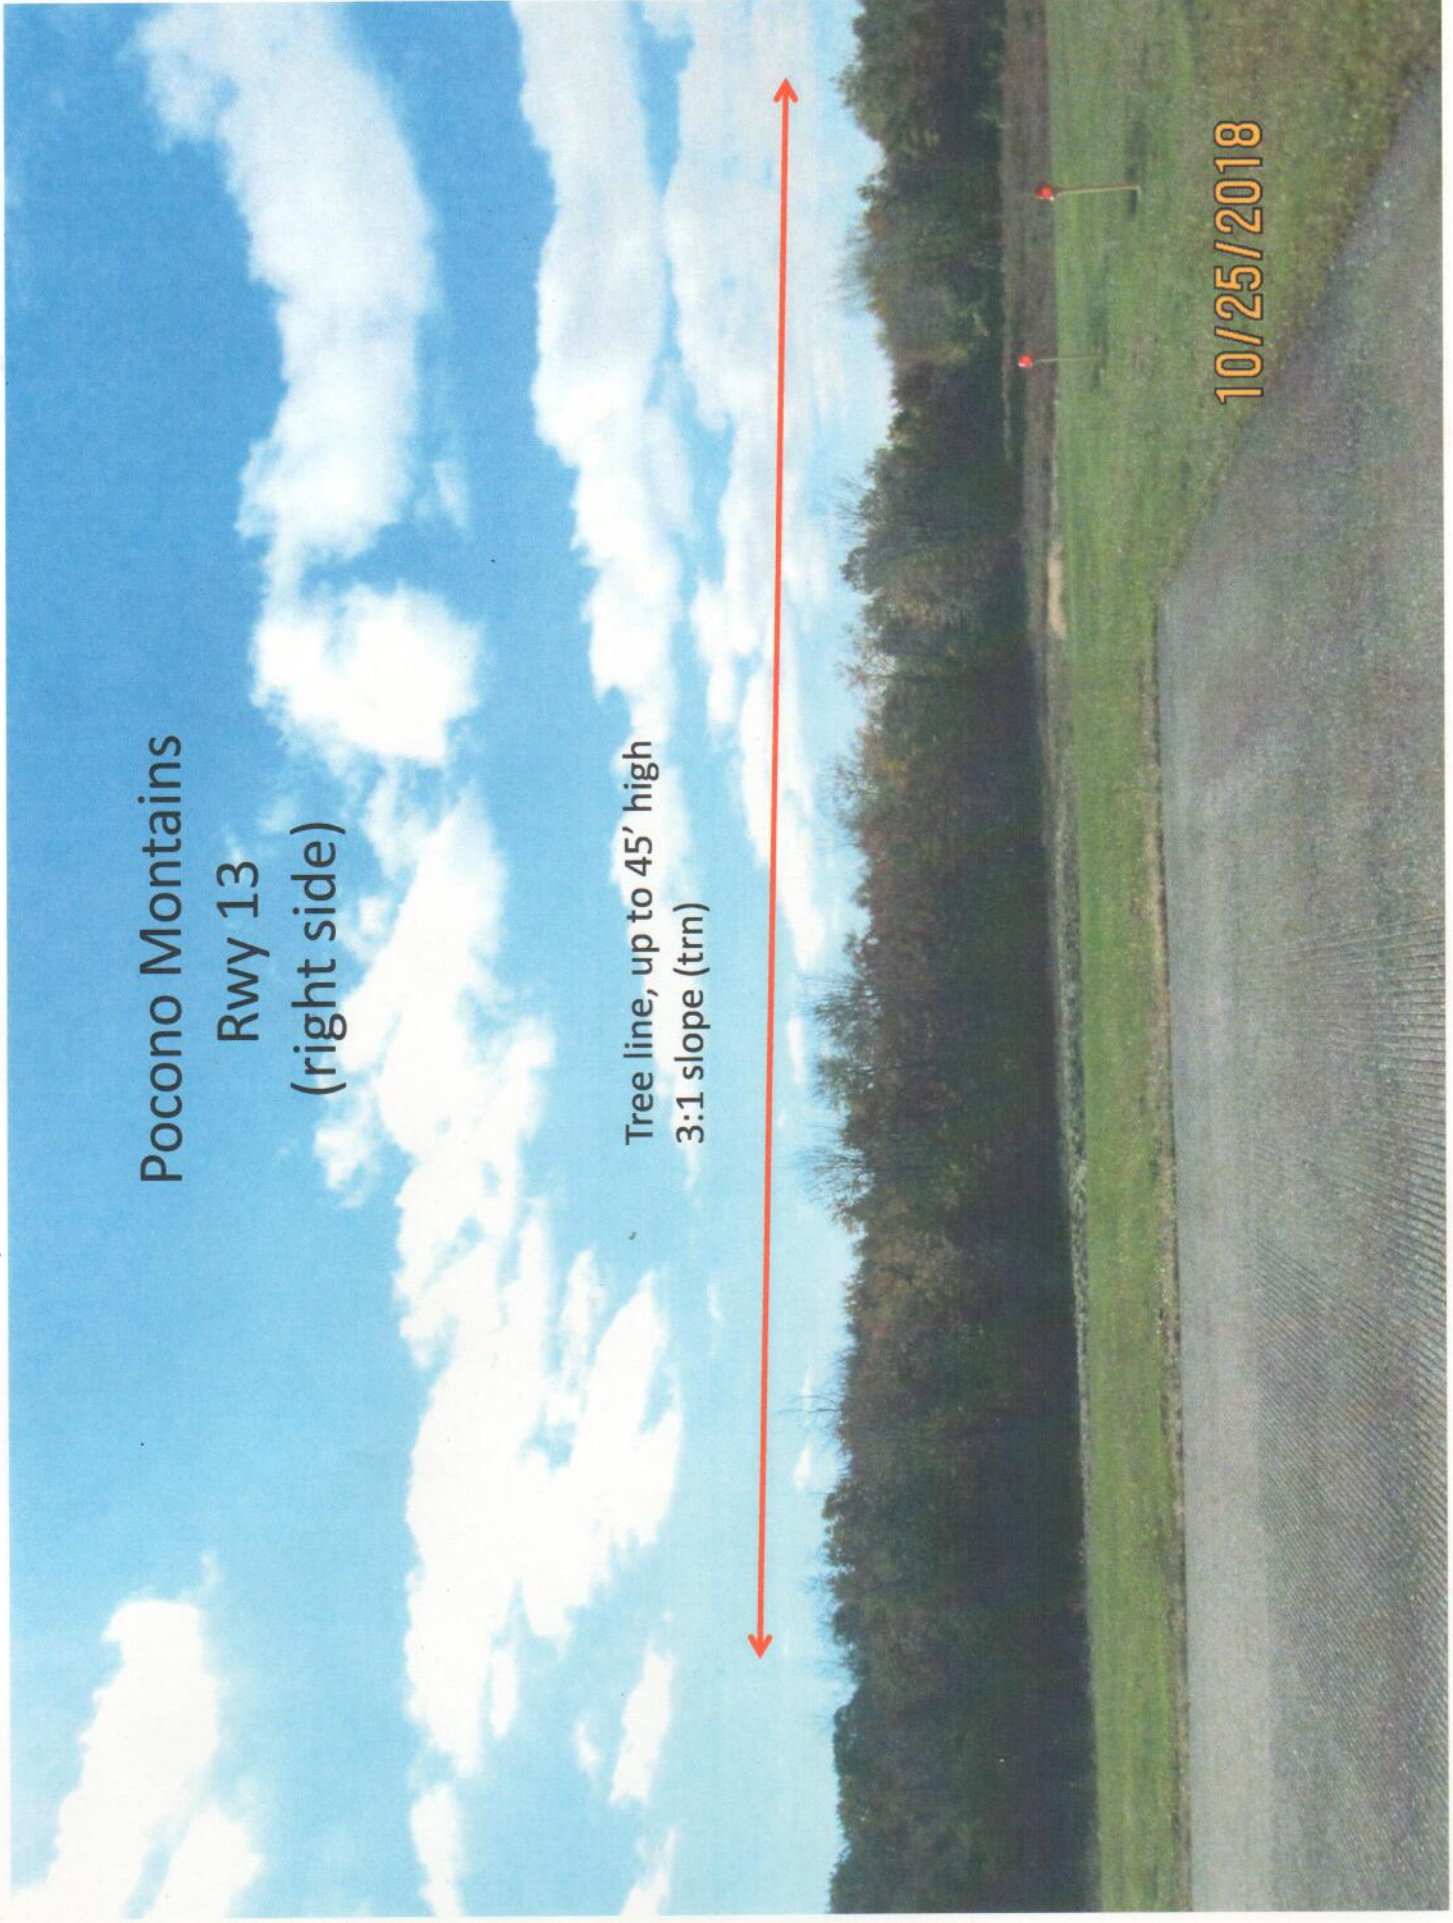
Pocono Mountains
Rwy 13
(right side)

Tree line, up to 45' high
3:1 slope (trn)

- a. Trees, 1,671' back, 264' right, 40' high (0:1 slope)
- b. Tree line 43' back, 411' right, 45' high (3:1 slope)
- c. Trees 416' out, 375' right, 46' high (2:1 slope)

NOTE: The above transitional surface obstructions are considered **hazards to the runway's navigable airspace** and should be mitigated at the earliest opportunity. If you are unable to remove or lower the transitional trees recommend completing an FAA Form 7460-1, for a formal assessment by the FAA on their acceptability. The completed form should be forwarded to the Bureau for review and subsequent forwarding to the FAA. Feel free to contact your regional specialist if you need assistance.
